November 23, 2006

**100 E Knoll Dr
Eagle, ID 83616**

Prepared for: Mr. Troy Farmer

Prepared by: Presidential Inspections LLC

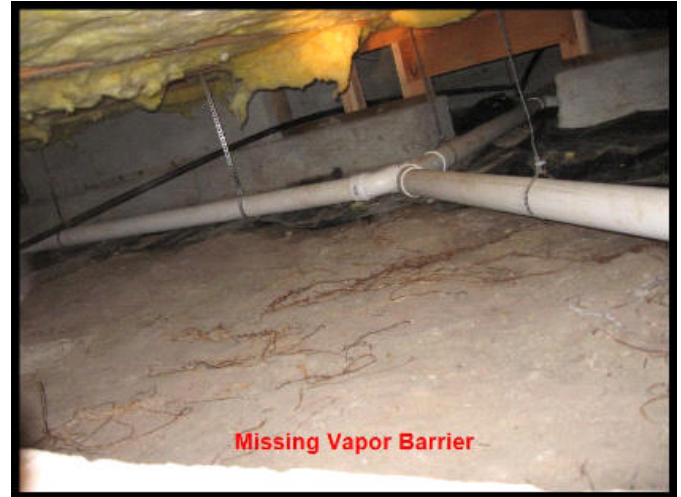
There is no vapor barrier installed in the NE section of the crawl space.

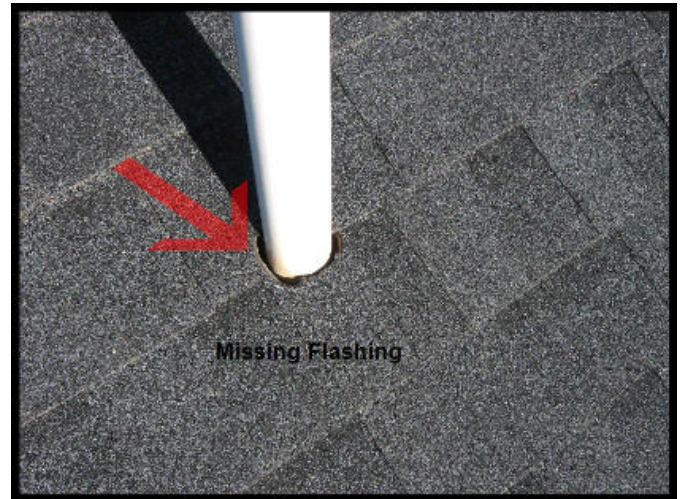
Flashing is missing on the roof top vents, recommend calling a licensed roofer to make repairs as needed.

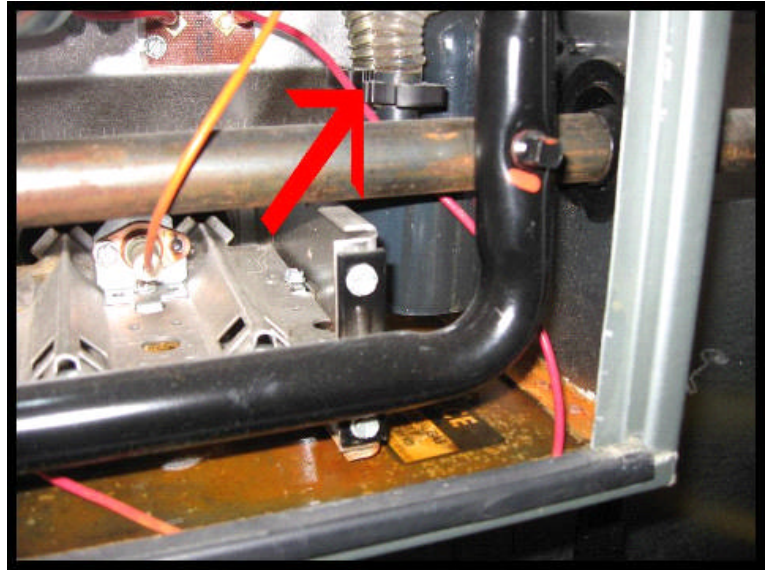
Water is actively leaking from the interior of the furnace, recommend the furnace be serviced by a licensed HVAC tech.

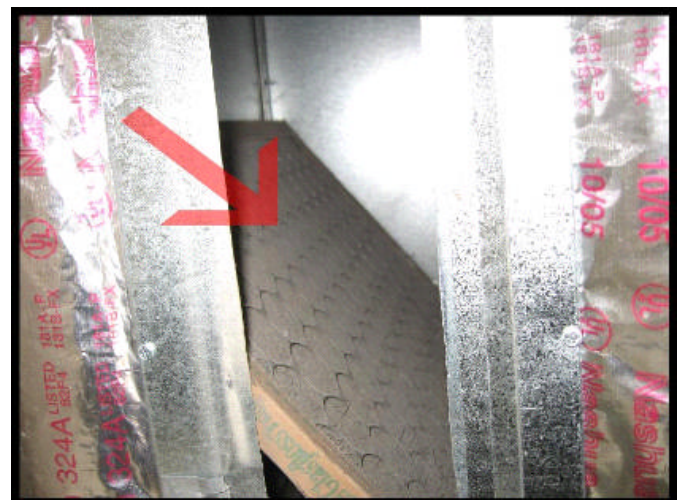
The filter is in need of cleaning or replacement. Replacing or cleaning filters every 30 to 45 days is recommended.

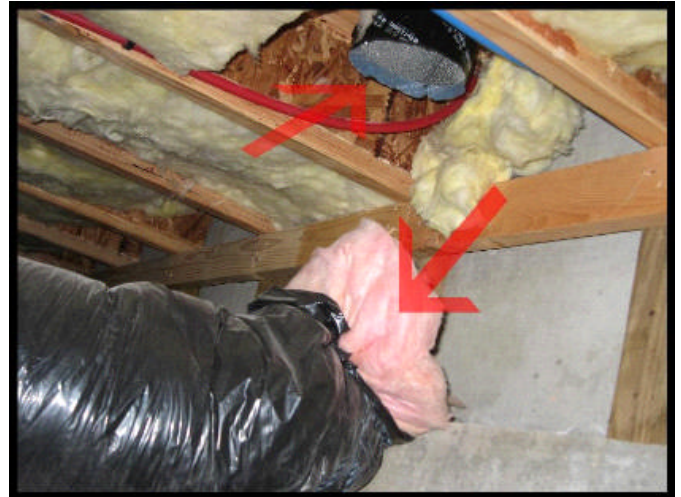
Flexible Round, Ductwork is loose or disconnected in the southeast corner of the crawl space.

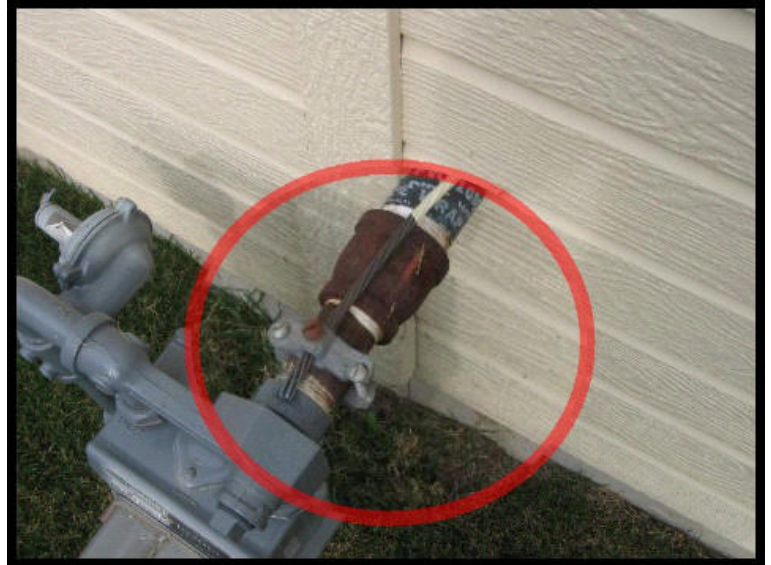
No Grounding wires should be affixed to the gas meter/line.

**No Grounding wires should
be affixed to the gas
meter/line.**

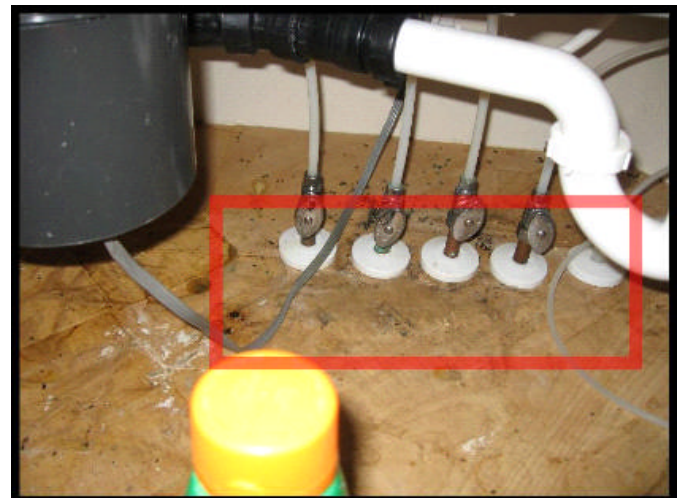
Active leak was noted under the sink, recommend repair.

**Active leak was noted under the sink,
recommend repair.**

mice droppings were also noted.

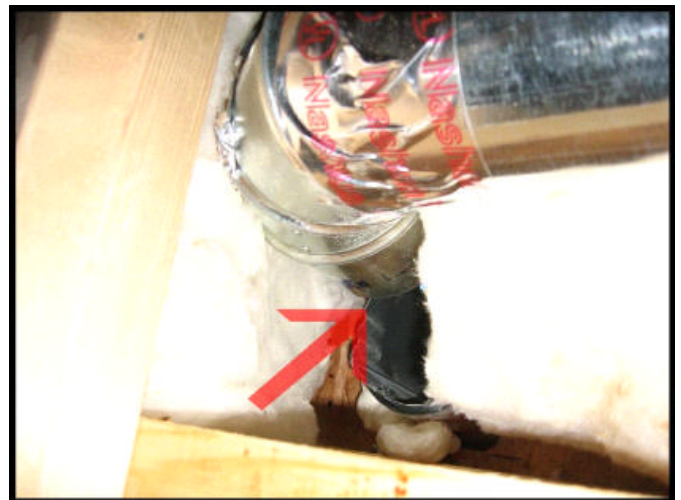
Dryer vent in the crawl space is disconnected and needs re attaching prior to use.

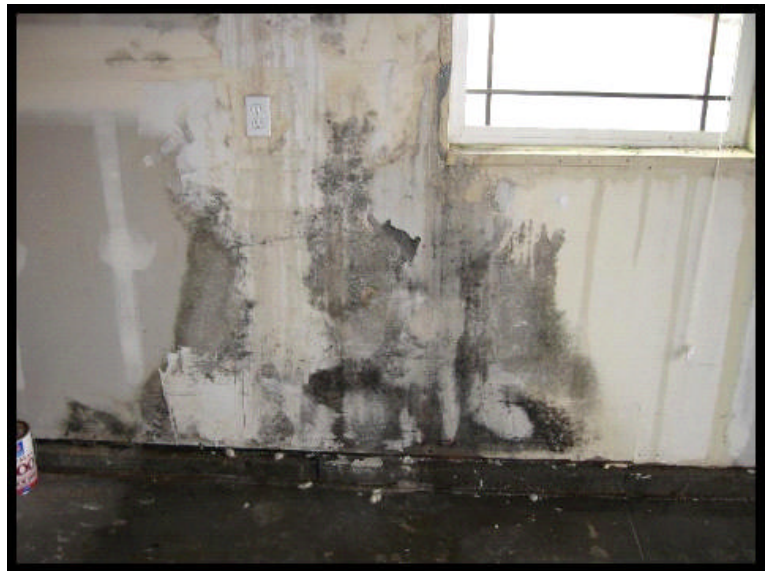
The main water line that connects to the water heater has burst and went unnoticed causing excessive fungi growth on the sheetrock next to the window.

Recommend the area be remediated by a licensed professional. The water valve has since been repaired.
