# INSPECTION REPORT

5555 Sample ST.  
Meridian, ID.

**Prepared by: Summit Home Inspections**  
**(208) 559 - 4102**  
**Email [-harry@summitinsp.com](mailto:-harry@summitinsp.com)**  
**www.summitinsp.com**  
**For the Exclusive use of**  
**John Doe**

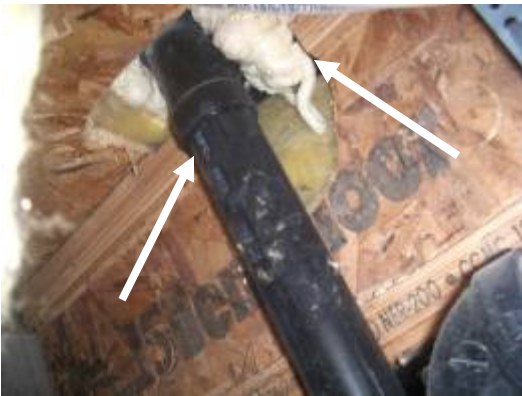
1. Found a 1 foot section of the floor joist directly under the tub in the master bathroom modified beyond limits. NO modification of the top flange or bottom flange of the joist is allowed recommend additional support under the modified area. FLOOR JOIST – “T”-joist flanges should not be notched, small holes are usually allowed anywhere in the web, while large holes (Typically, holes NOT GREATER than 1/3 the depth of the joist can be installed anywhere in the joist as long as they are 2 inches or more from the top or bottom of the joist) are limited to the middle span. See Photo P#4

Found a 1 foot section of the floor joist directly under the tub in the master bathroom modified beyond limits. NO modification of the top flange or bottom flange of the joist is allowed recommend additional support under the modified area. FLOOR JOIST – “T”-joist flanges should not be notched, small holes are usually allowed anywhere in the web, while large holes (Typically, holes NOT GREATER than 1/3 the depth of the joist can be installed anywhere in the joist as long as they are 2 inches or more from the top or bottom of the joist) are limited to the middle span.

NO modification allowed to the top or bottom flanges.

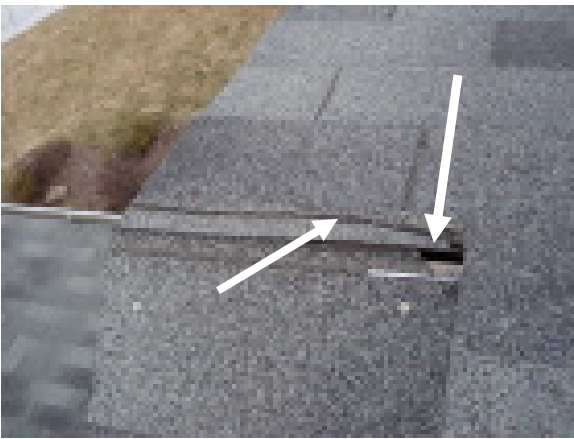
2. Found the cap shingles missing from the overhang area above the front upstairs bedroom. Repair as needed. See Photo P#5
3. Surface drainage could be improved to drain away from the foundation. Ideal grading slope away from the foundation is 1 inch per foot for 6 feet

Found the cap shingles missing from the overhang area above the front upstairs bedroom. Repair as needed.

Cap shingle missing  
Notice the hole where water might enter.

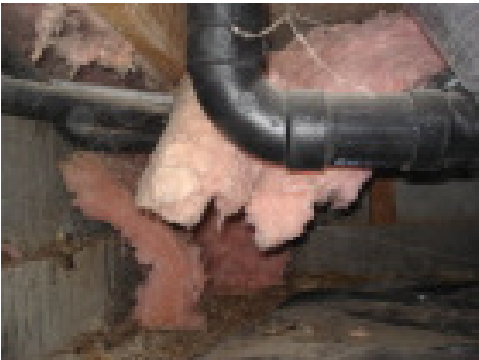
9. A few insulation batts in the floor under the utility room have come down. The waste disposal had a slight ticking noise in it. See Photo P#12

A few insulation batts in the floor under the utility room have come down.

Insulation batts under the floor
