Valley Home Inspection

GENERAL INFORMATION

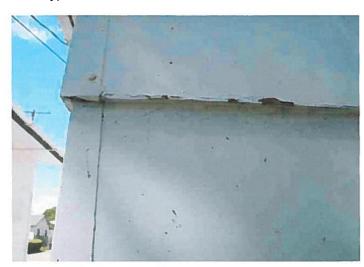
1.19 - The exterior of the house is in need of typical maintenance type service such as setting and sealing loose nails, calking openings that have developed at the seams and at overdriven nails, sealing penetrations and painting exposed portions of wood. All of which will prolong the life of the structure.

needs typical maintenance - Continued

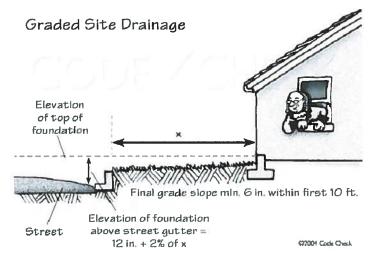
1.24 - Grading and drainage is either negative or neutral adjacent to the perimeter of the house and moisture intrusion within the crawlspace will remain a possibility. The soil or the hard surfaces should slope away from the residence to a distance of at least six feet, to keep moisture away from the footings.

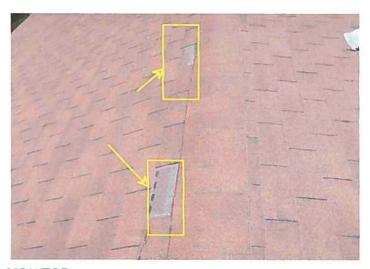
3.5 - There are 3 areas on the roof where the wind has broken the shingles exposing the underlying materials. We recommend the further review, advice and services of a roofing contractor for repair.

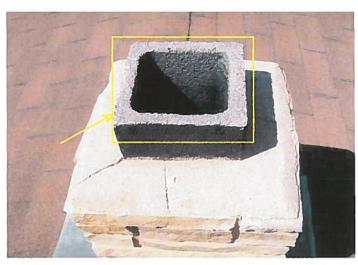
4.2 - We recommend that a sheet metal cap be installed over the abandoned chimney to keep rain water from funning down the chimney flue into the basement.

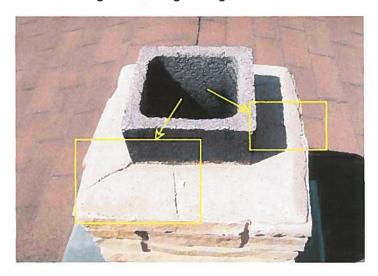
4.3 - The crown on top of the furnace chiminey, which is designed to seal the chimney wall and shed rainwater, is cracked in several places and should be sealed to prevent water from penetrating the cap, freezing and causing damage.

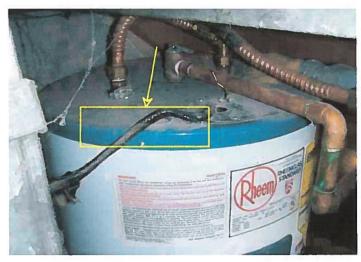
5.12 - Electrical wiring to the water heater should be protected within conduit to at least 7' from the floor.

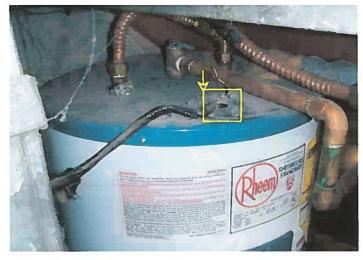
5.13 - The electrical wire clamp is missing at the water heater and should be replaced to prevent damage to the wire.

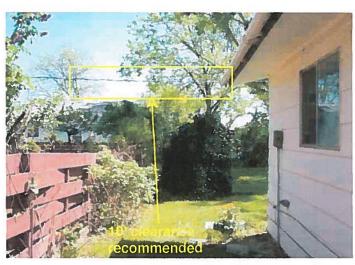
Service Drop Clearances

6.4 - The overhead conductor lines to the house pass too low over the low pitched garage roof. Common safety standards require them to pass eight feet above a walkable flat roof or that which has less than a 5:12 pitch, and you may wish to consult an electrician about this for repair or be prepared to take responsibility for them and warn anyone that accesses the roof.

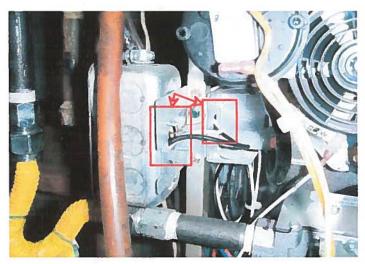
- 6.13 There are cover plates missing on outlets throughout the house, which is potentially dangerous and cover plates should be installed.
- 6.14 A wire entering a metal box in the furnace are not clamped or otherwise protected from damage. This should be serviced by a licensed electrician.

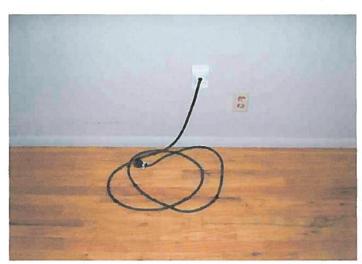
6.15 - The outlet on the east side of the house is powered by an extension cord in the bedroom. We recommend that it be permanently wired with appropriate materials, by a licensed electrician.

The outlet on the east side of the house is powered by an extension cord - Continued

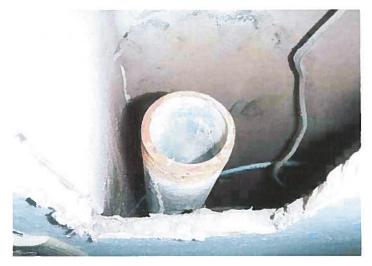
9.3 - We have detected a mold-like substance in the wall at the laundry drain which should be evaluated by a mold specialist and/or properly remediated. Molds flourish in a damp environment and many are commonplace, but some are toxic and represent a health threat. You can learn more about mold, including how to clean up small areas yourself, from a document issued by the Environmental Protection Agency entitled "A Brief Guide to Mold, Moisture and Your Home, by visiting their web site at http://www.epa.gov/mold/moldguide.html , which can be downloaded.

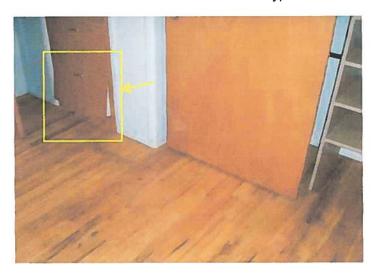
14.2 - The cabinet drawer will need typical hardware service to function properly.

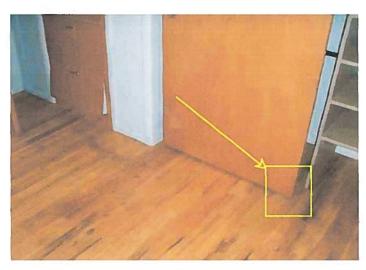
14.3 - There are no floor guides on the bypass closet doors which should be installed to prevent someone's foot from being pinched under the door.

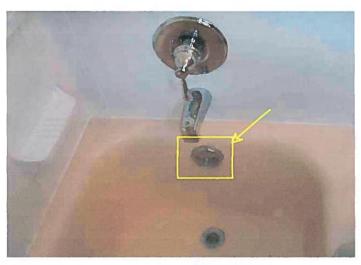
15.2 - The mechanical tub stopper does not dis-engage, and the lever housing is damages. It will need to be serviced to function correctly.

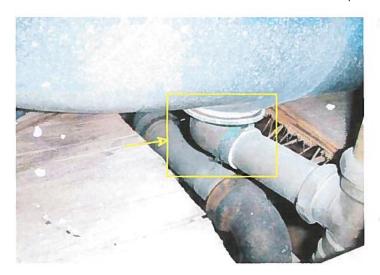
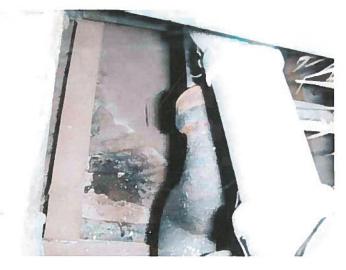
15.3 - There is a drain leak below the tub/shower, which should be repaired.
