<u>DIBATTISTO ASSOCIATES, LLC</u>

Lacey Allain and Alex Turcotte Project Address: 101 Riverside Drive Vernon, CT 06066

Structural Examination of Concrete Foundation Walls

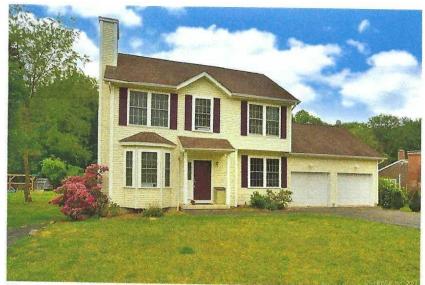
The evaluation of the home, as seen in photograph 1, began with a visual examination of the interior foundation walls. Only a small portion of the foundation walls were visible from the interior of the basement area, as most of the basement was finished. There was no cracking worth noting seen from the interior side of the foundation walls.

Photograph 1: Exterior of Home

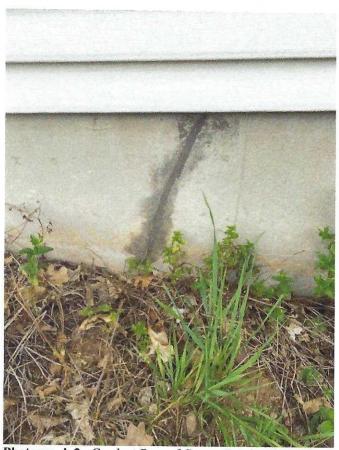
The evaluation concluded with a visual examination of the exposed foundation walls on the exterior of the home. There was one crack at the rear of the garage that had been previously filled and repaired. This crack, which can be seen in photograph 2, was found to be in good condition. There were also several vertical shrinkage cracks seen in the garage foundation walls as seen in photograph 3.

Photograph 2: Crack at Rear of Garage Previously Filled

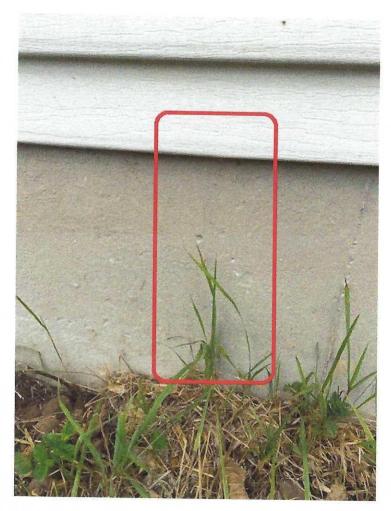
Photograph 3: Shrinkage Crack at Garage Wall
