# FOUNDATION INSPECTION REPORT

247 Clark Hill Road

East Haddam, CT 06423

Engineering Firm: Taddonio Engineering, LLC

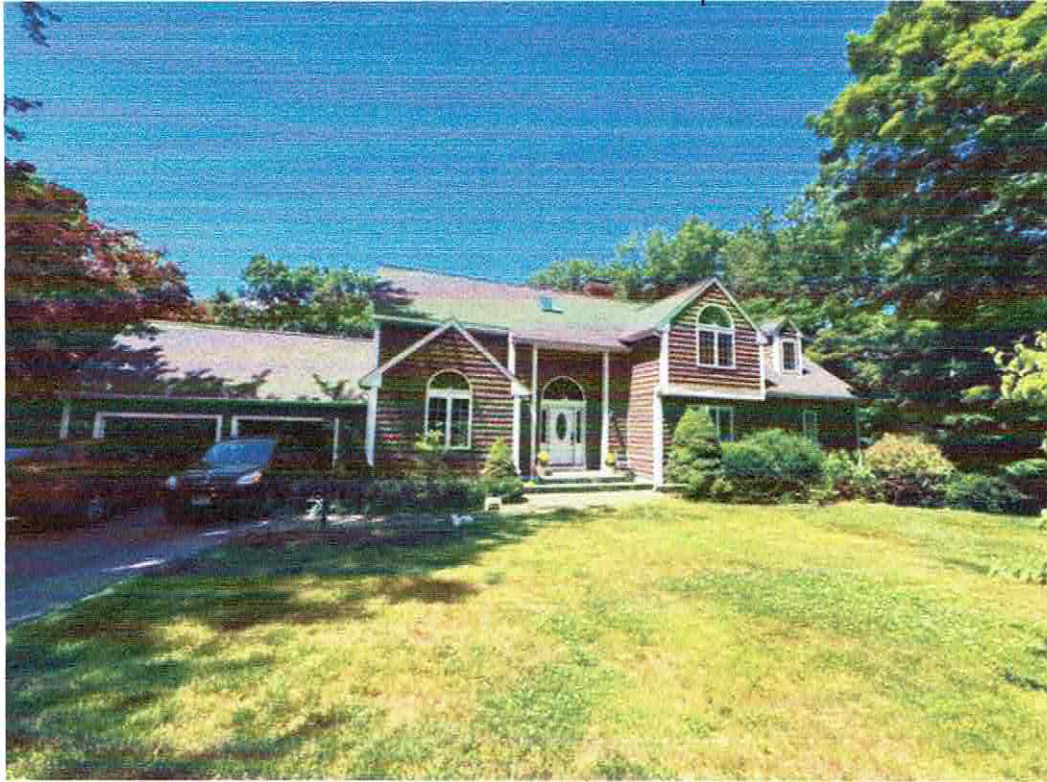
**Front Wall:** There were no visible cracks or deficiencies in this wall.

View of front side of house.

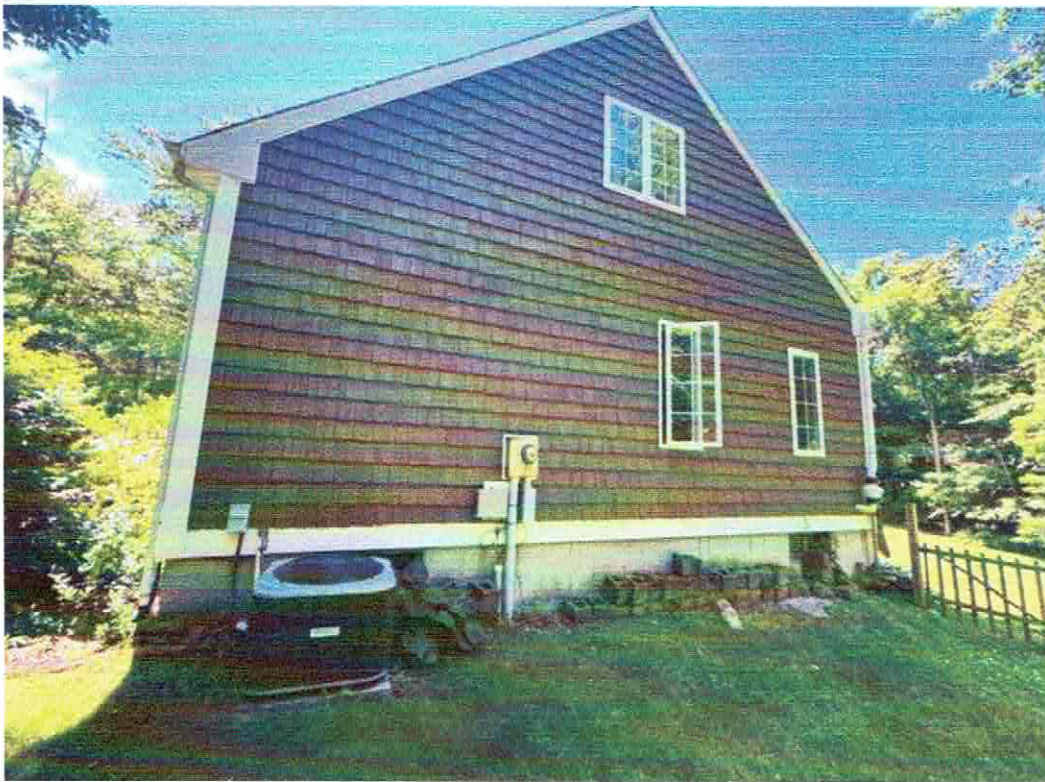
**Right Wall:** There were no visible cracks or deficiencies in this wall.

View of right side of house.

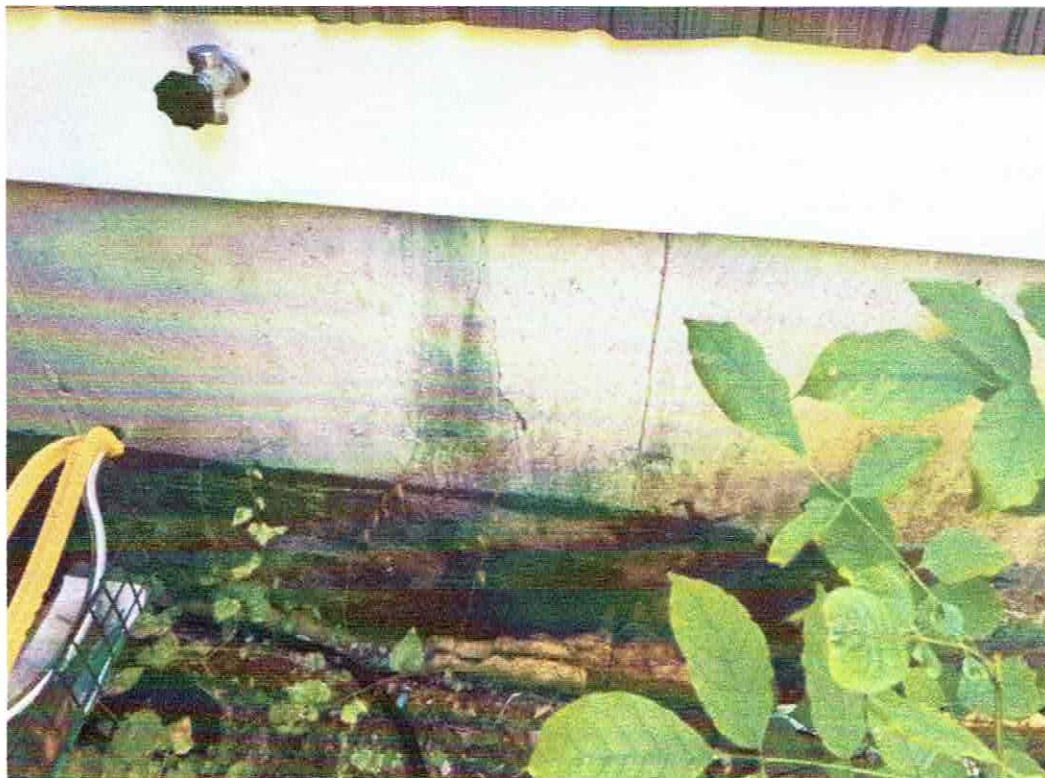
**Rear Wall:** There is a vertical crack in the rear wall near left corner of house open up to 1/16" wide. There is a vertical crack in the rear wall of garage up to 1/2" that was patched prior to current owner, over 12 years ago, that has slightly reopened.

The cracks seen in the rear wall and left wall of main foundation are from past settlement. The cracks were sealed by a previous owner and have since reopened slightly. The foundation is found to be stable and cracks should be monitored for any changes. They can be sealed with epoxy injection to help keep out pests and water.

View of settlement crack in rear wall near left corner of house foundation.

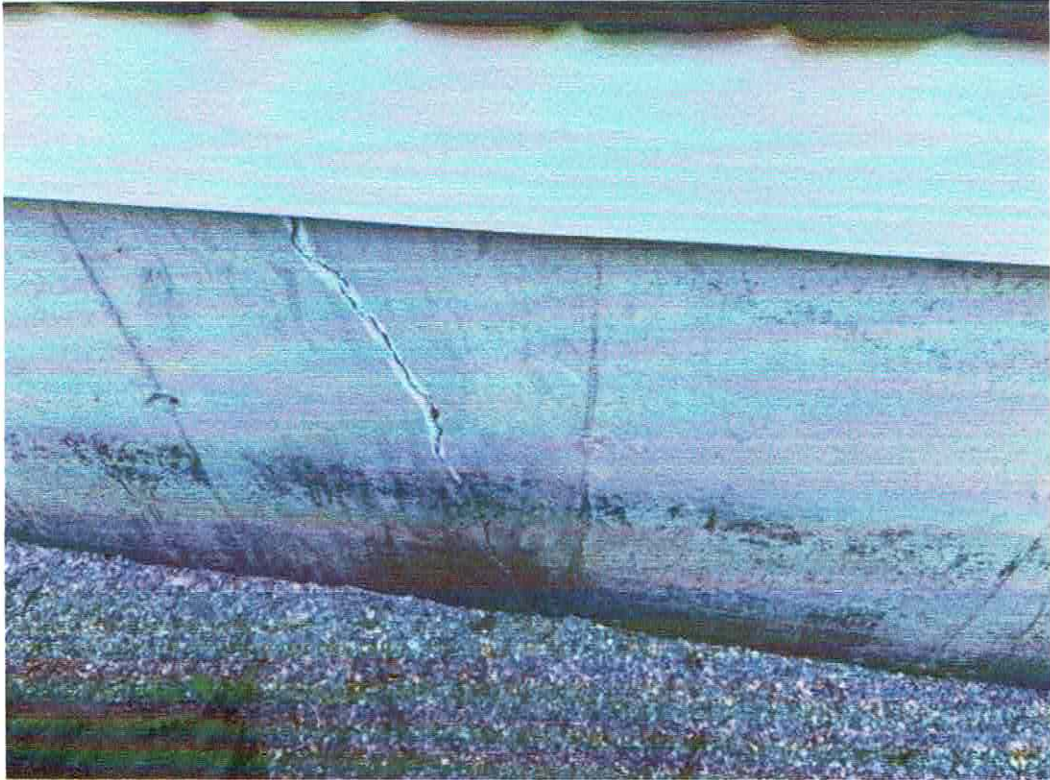
View of crack in rear wall of garage.

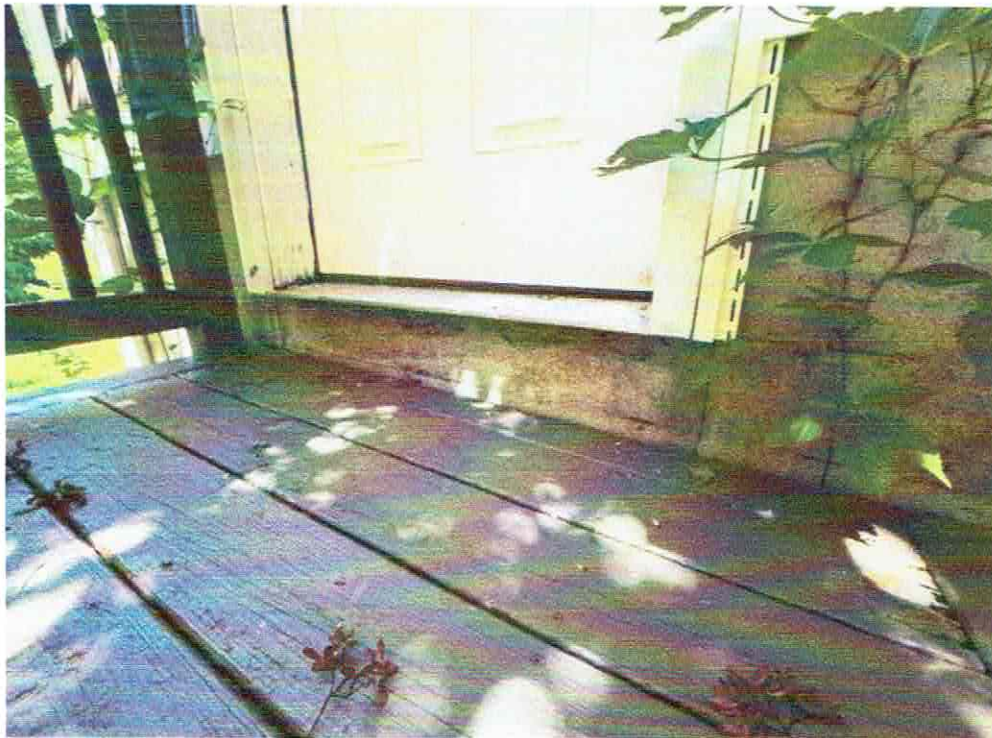
**Left Wall:** The left wall of the house foundation has a vertical crack in the middle up to 1" wide that has been previously patched but reopened. The crack is visible inside the basement and extends under the main floorbeam. There is no sign of movement of the beam due to the crack. The left wall of the garage has no visible cracks but there is a visible joint where the floor slab is poured over the foundation wall. This is not a structural issue and only a joint.

View of slab over left wall of garage joint.

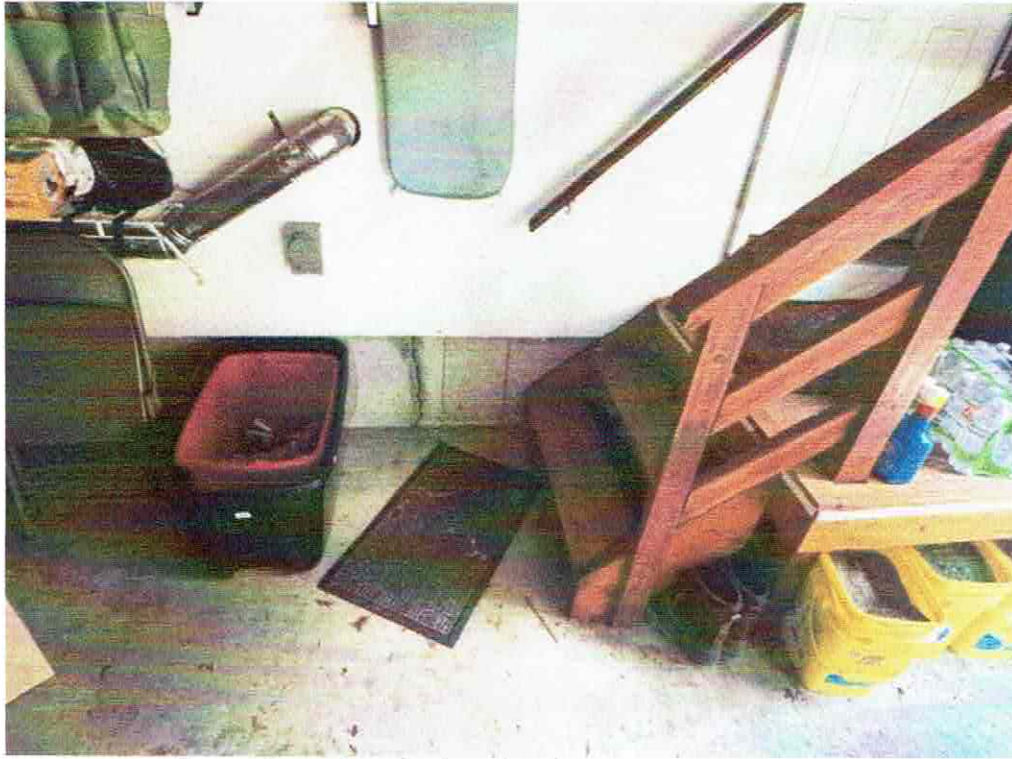
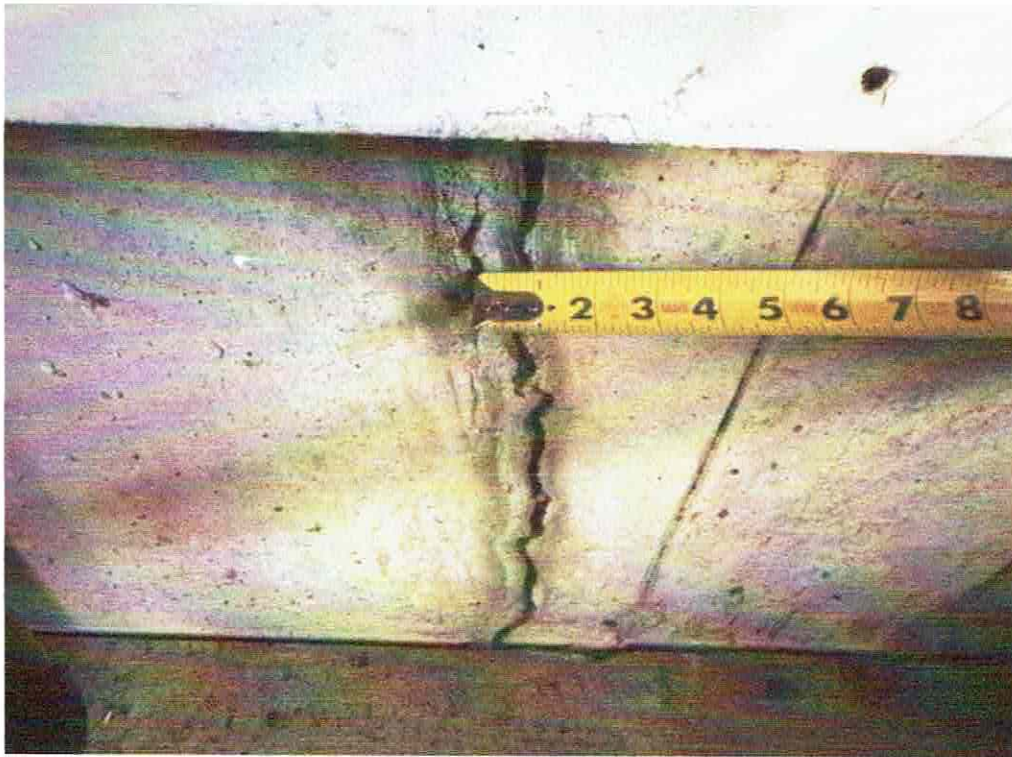
View of crack in left wall of house foundation.

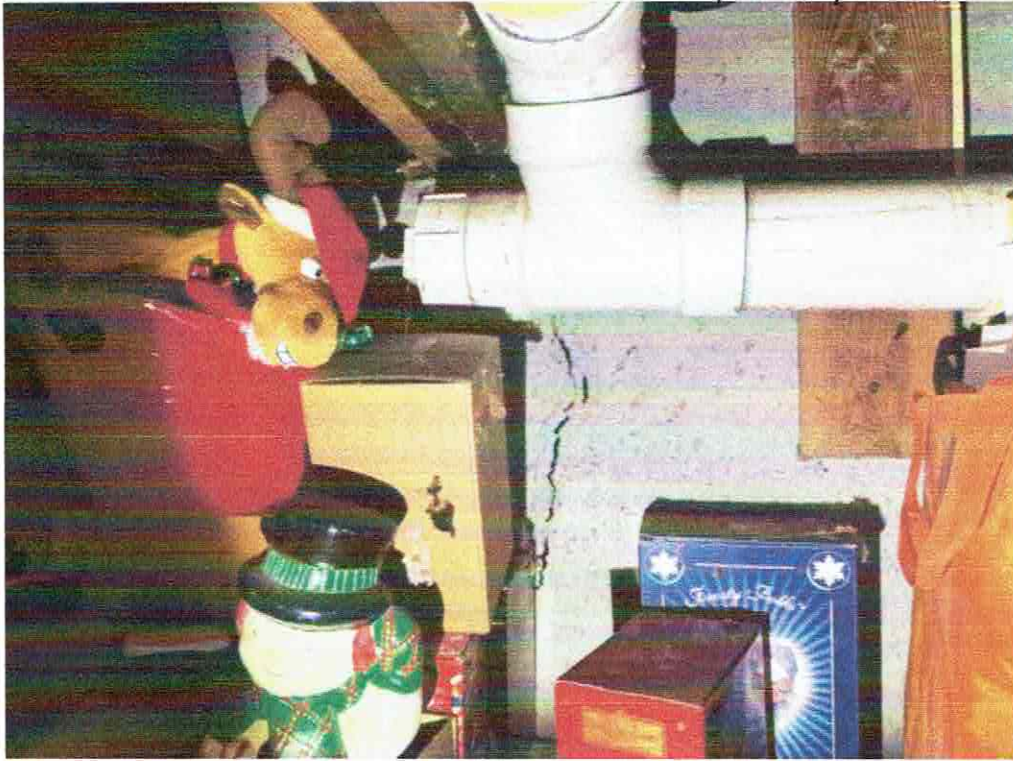
View of crack in left wall of foundation seen from basement.

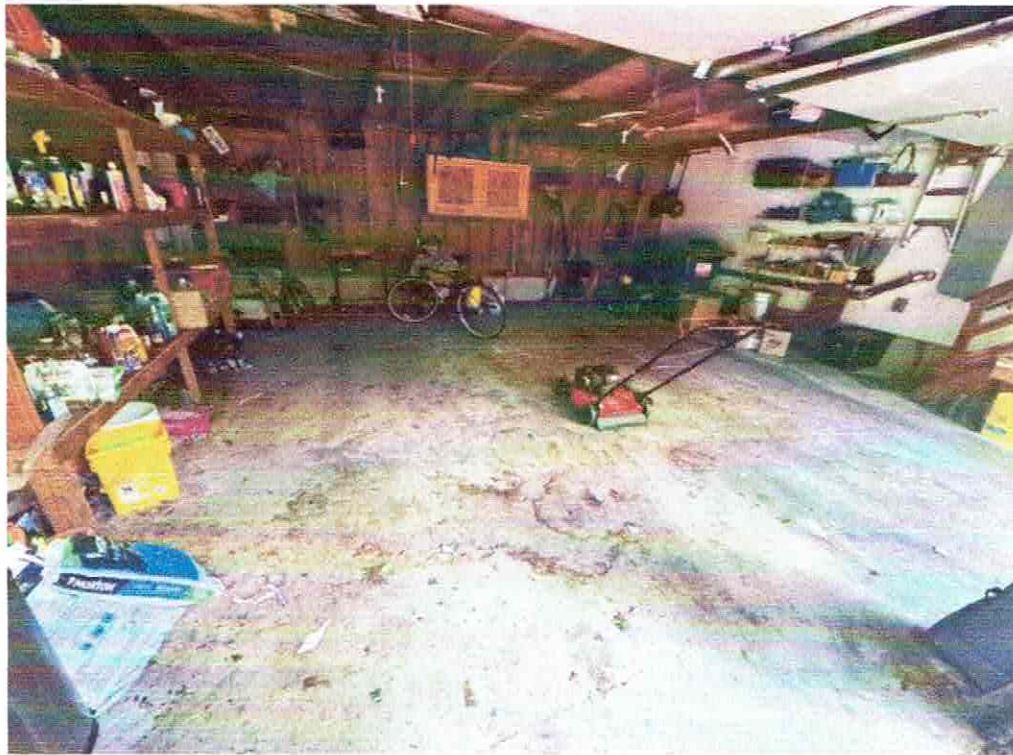
**Floor Slabs:** The floor slabs in the garage and basement have various hairline cracks that are to be monitored and not a structural concern.

View of garage floor slab.

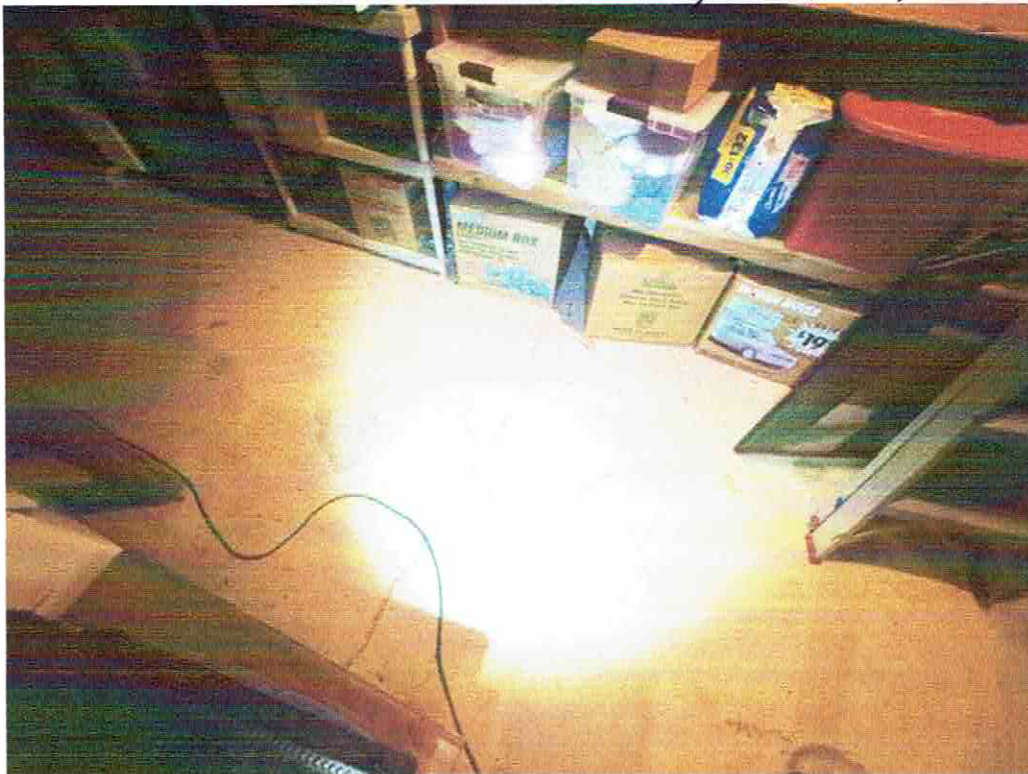
View of cracks in basement floor slab.
