## Idaho Building Inspectors Property Inspection Report

Inspection prepared for: Date of Inspection: 5/14/2018 Time: 10 AM Age of Home: 2013 (5yrs) Size: 1736 Weather: 70F sunny

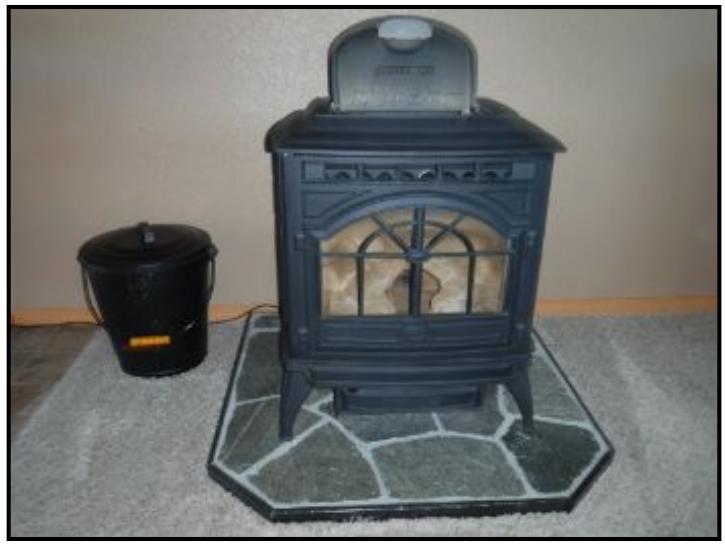
Informational: Quadra Fire pellet stove, refer to information on back of fireplace for clearances.

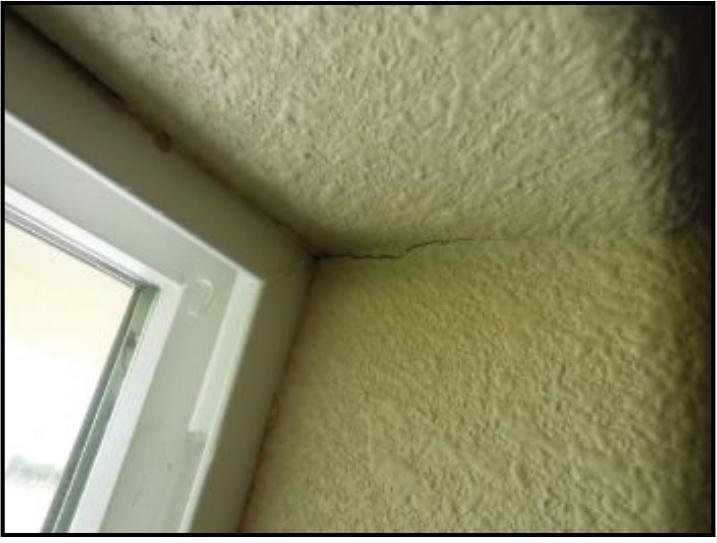
Operable and in satisfactory condition

Recommend light caulking around windows and doors as needed

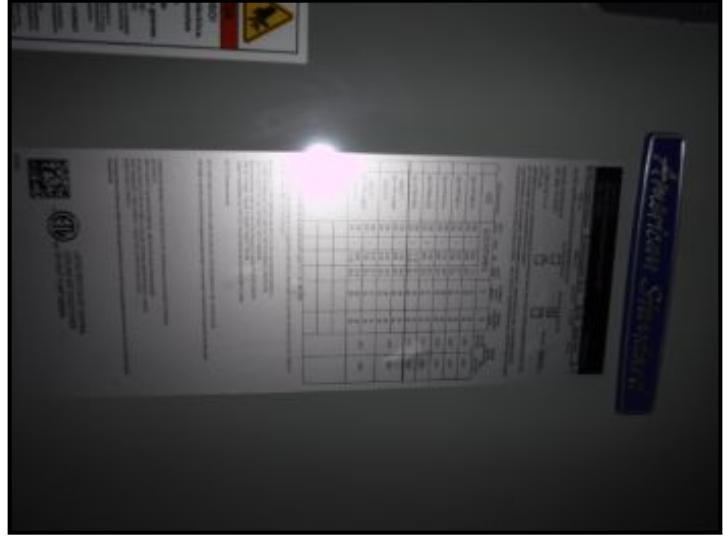
• Electric Furnace: Last service date is over one year ago, or is unable to be determined. Although this unit appears to be operating properly from controls, there are areas which cannot be seen without specialized equipment and training. Furnace specialists recommend a complete inspection annually; consider having unit inspected by certified HVAC technician.

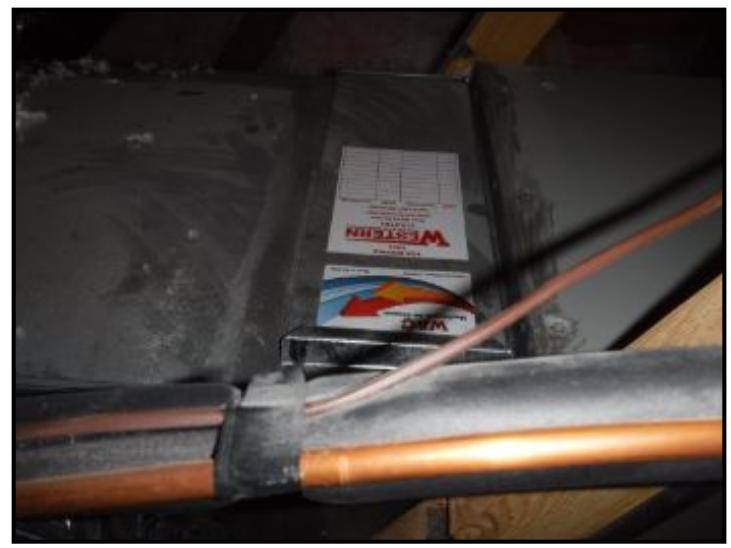
Filter screen located in attic next to electric furnace recommend service of filter
