## Idaho Building Inspectors Property Inspection Report

Inspection prepared for: Date of Inspection: 5/14/2018 Time: 10 AM Age of Home: 2013 (5yrs) Size: 1736 Weather: 70F sunny

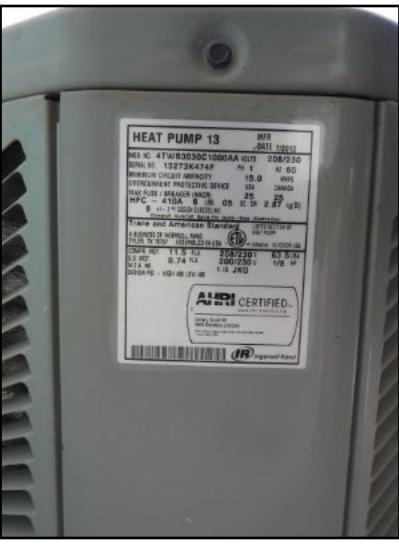
Heat Pump Information

Compressor Type: Electric Heat Pump noted Location: The compressor is located on the exterior west. Observations:

Appeared functional at the time of inspection.

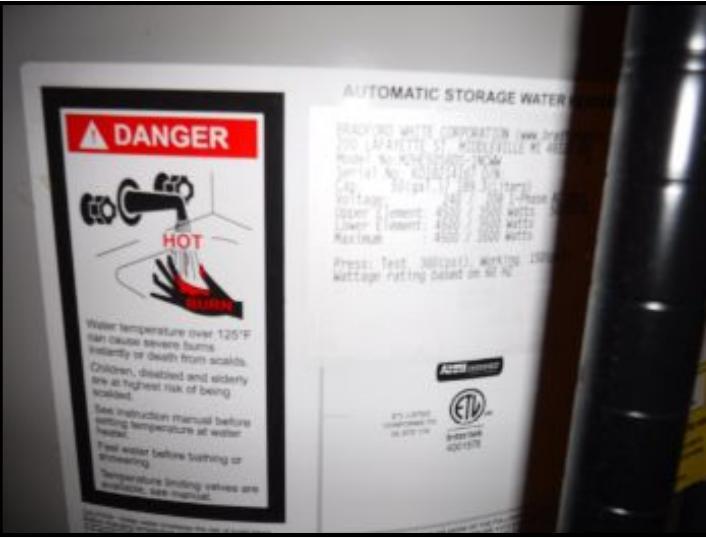
Informational

• A Temperature Pressure Relief (TPR) valve present. This safety valve releases water (and thus relieves pressure) if either the temp or pressure in the tank gets too high. The **TPR valve** discharge tube must be made of copper, iron, or CPVC (NOT regular **PVC**). It must terminate within 6" above the floor--the end cannot be threaded or have a fitting.

• No major system safety or function concerns noted at time of inspection.
