Valley Home Inspection

GENERAL INFORMATION

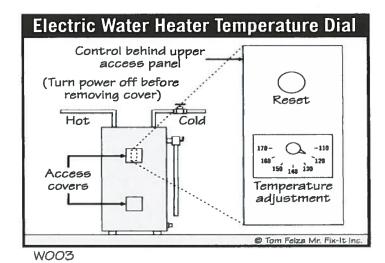
5.10 - There are a wide variety of residential electric water heaters that range in capacity from fifteen to one hundred gallons. They can be expected to last at least as long as their warranty, or from five to eight years, but they will generally last longer. However, few of them last longer than fifteen or twenty years and many eventually leak. So it is always wise to have them installed over a drain pan plumbed to the exterior. Also, it is prudent to flush them annually to remove minerals that include the calcium chloride bi-product of many water softening systems. The water temperature should be set at a minimum of 110 degrees fahrenheit to kill microbes and a maximum of 140 degrees to prevent scalding. Also, water heaters can be dangerous if they are not seismically secured and equipped with a pressure/temperature relief valve and discharge pipe plumbed to the exterior.

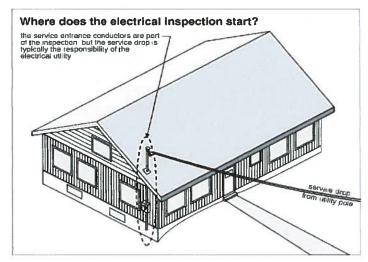
6.1 - National safety standards require electrical panels to be weatherproof, readily accessible, and have a minimum of thirty-six inches of clear space in front of them for service. Also, they should have a main disconnect, and each circuit within the panel should be clearly labeled. Industry standards only require us to test a representative number of accessible switches, receptacles, and light fixtures. However, we attempt to test every one that is unobstructed, but if a residence is furnished we will obviously not be able to test each one.

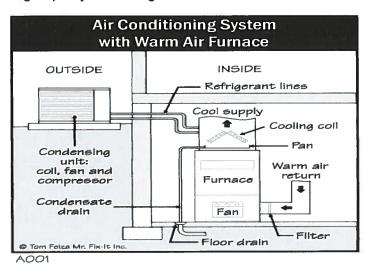
General Evaluation

Serviceable Component or Condition
